Balloon Working Group Meeting

The NASA Ultra Long Duration Balloon Vehicle

Henry M. Cathey, Jr.
ULDB Balloon Vehicle Manager
NMSU/Physical Science Laboratory
Wallops Flight Facility

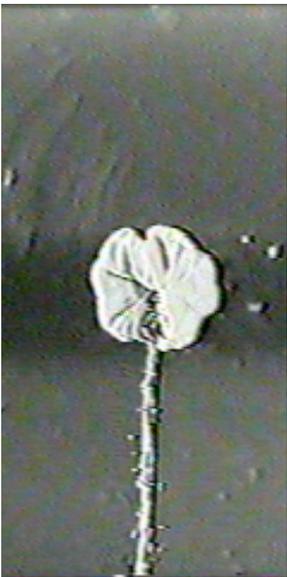
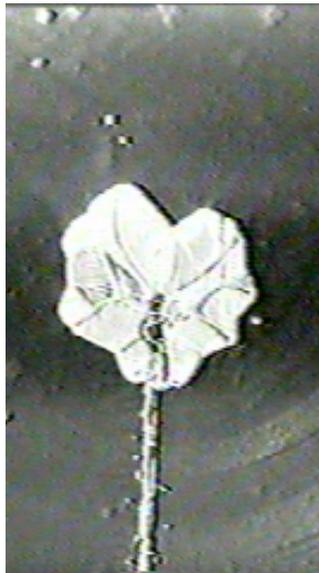
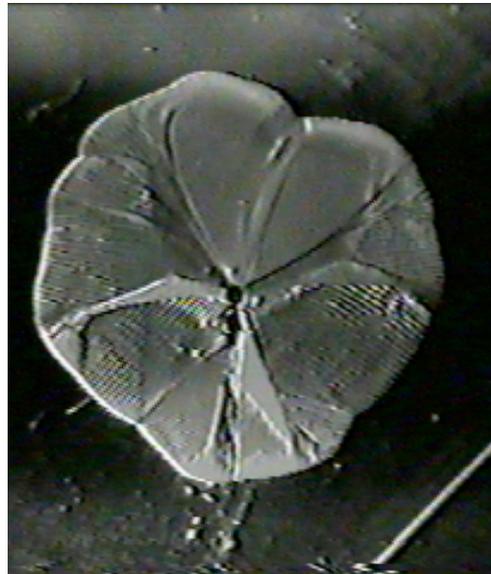
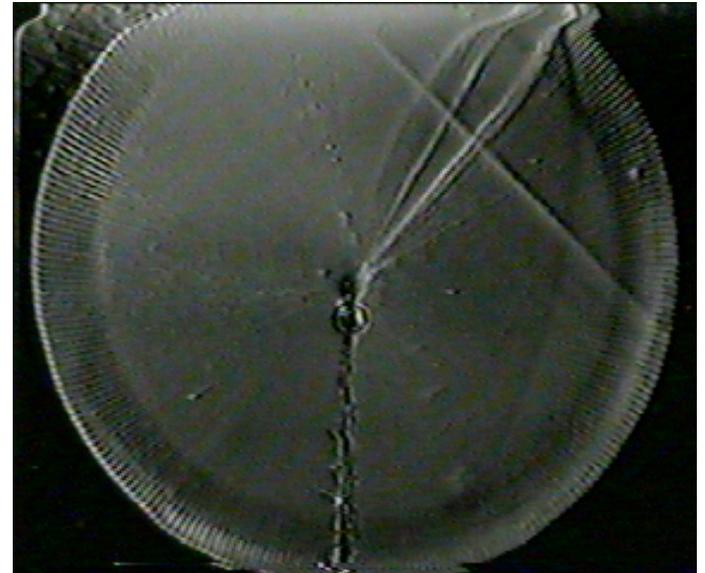
Up-Looking Video

- Balloon pressurization and stable altitude occurred at 32.8 km (107,500 ft) (GPS altitude 33.8 km or 111,000 ft)
- Maximum daytime pressurization 120 Pa
- Observations and decision
 - Telescope observation showed shape discontinuity in the balloon
 - Flight continued through the day with minor variations in pressure observed
 - Altitude was very stable, holding at 32.8 km (107,500 ft) plus or minus 120 m (400 ft.)
- The decision was made to continue with the flight because performance was very close to that predicted and the pressure and altitude were very stable.

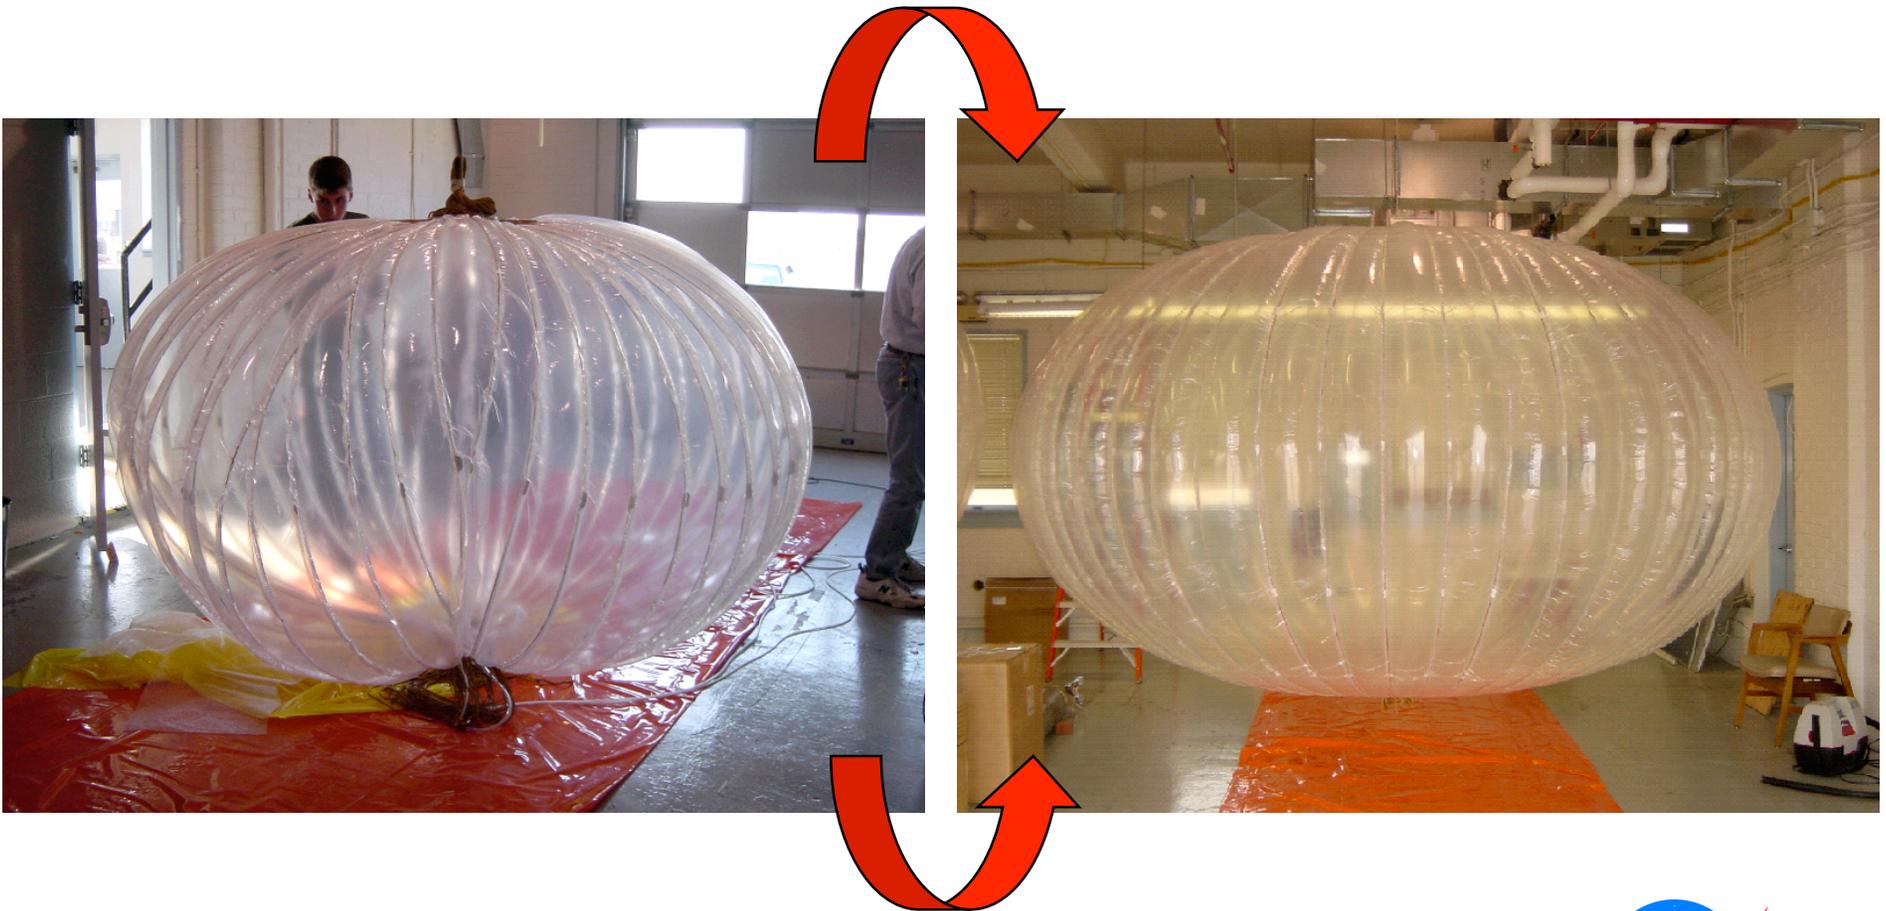
Remove Excess Material for Proper Deployment

- Material Deficiency in Shell Film
- Study Shape Anomaly
 - Removed “excess film” from the design
- Material Redesign
- Model Balloon Tests
- Payload Requirement Increase (2,720 kg or 6,000 lbs)

- Two areas required improvements – Materials and Deployment
- Materials
 - Very **high rate** (“snatch testing”) and very **low rate** (creep testing) loading requirements
 - Developed and selected new material
 - New material meets existing proven standards and improved “dart impact” characteristics, high strain rate characteristics, and acceptable long term creep
- Structural
 - Deployment issue studied
 - New design criteria developed and documented – includes material requirements, service life considerations, factors of safety, and more
 - Deployment test structures fabricated and tested

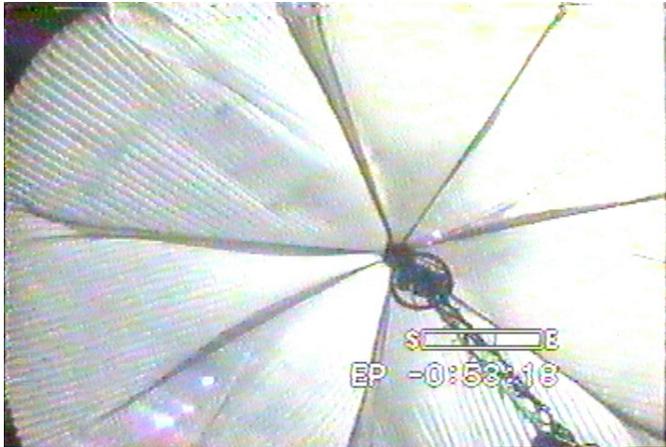
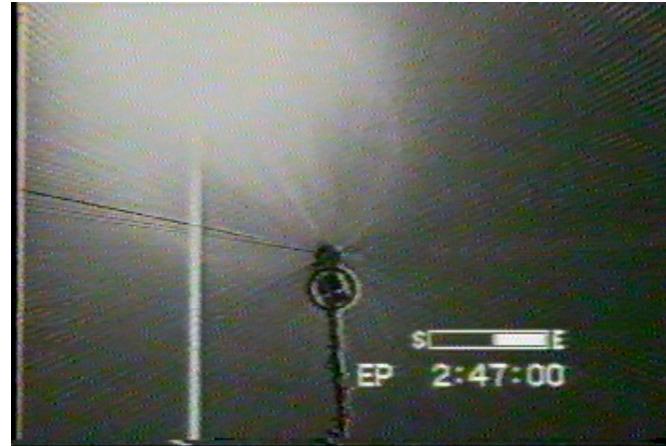
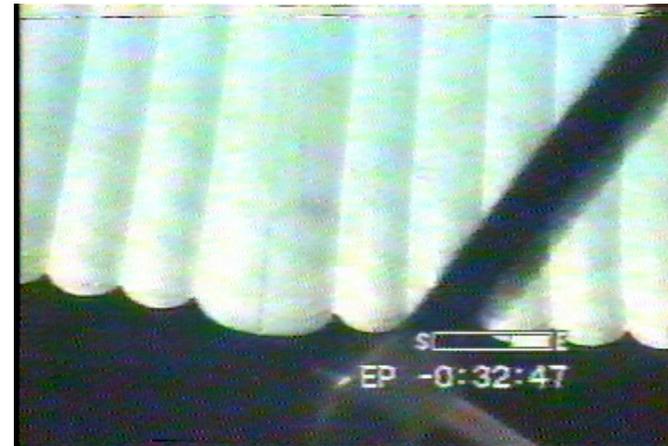
In Flight Video Captures

- Break down in manufacturing process
- Tendon attachment was a “blind” process
- Inspection of tendon attachment difficult - also a “blind” process
- Punctured tendons were inherent problem
- NSBF QA observed rather than inspected for this balloon
- Numerous recommendations made to BPO
- Full review and revision of production documentation completed – Material Specifications, Fabrication Procedures, and Quality Procedures
- Additional inspections with sign-off’s added

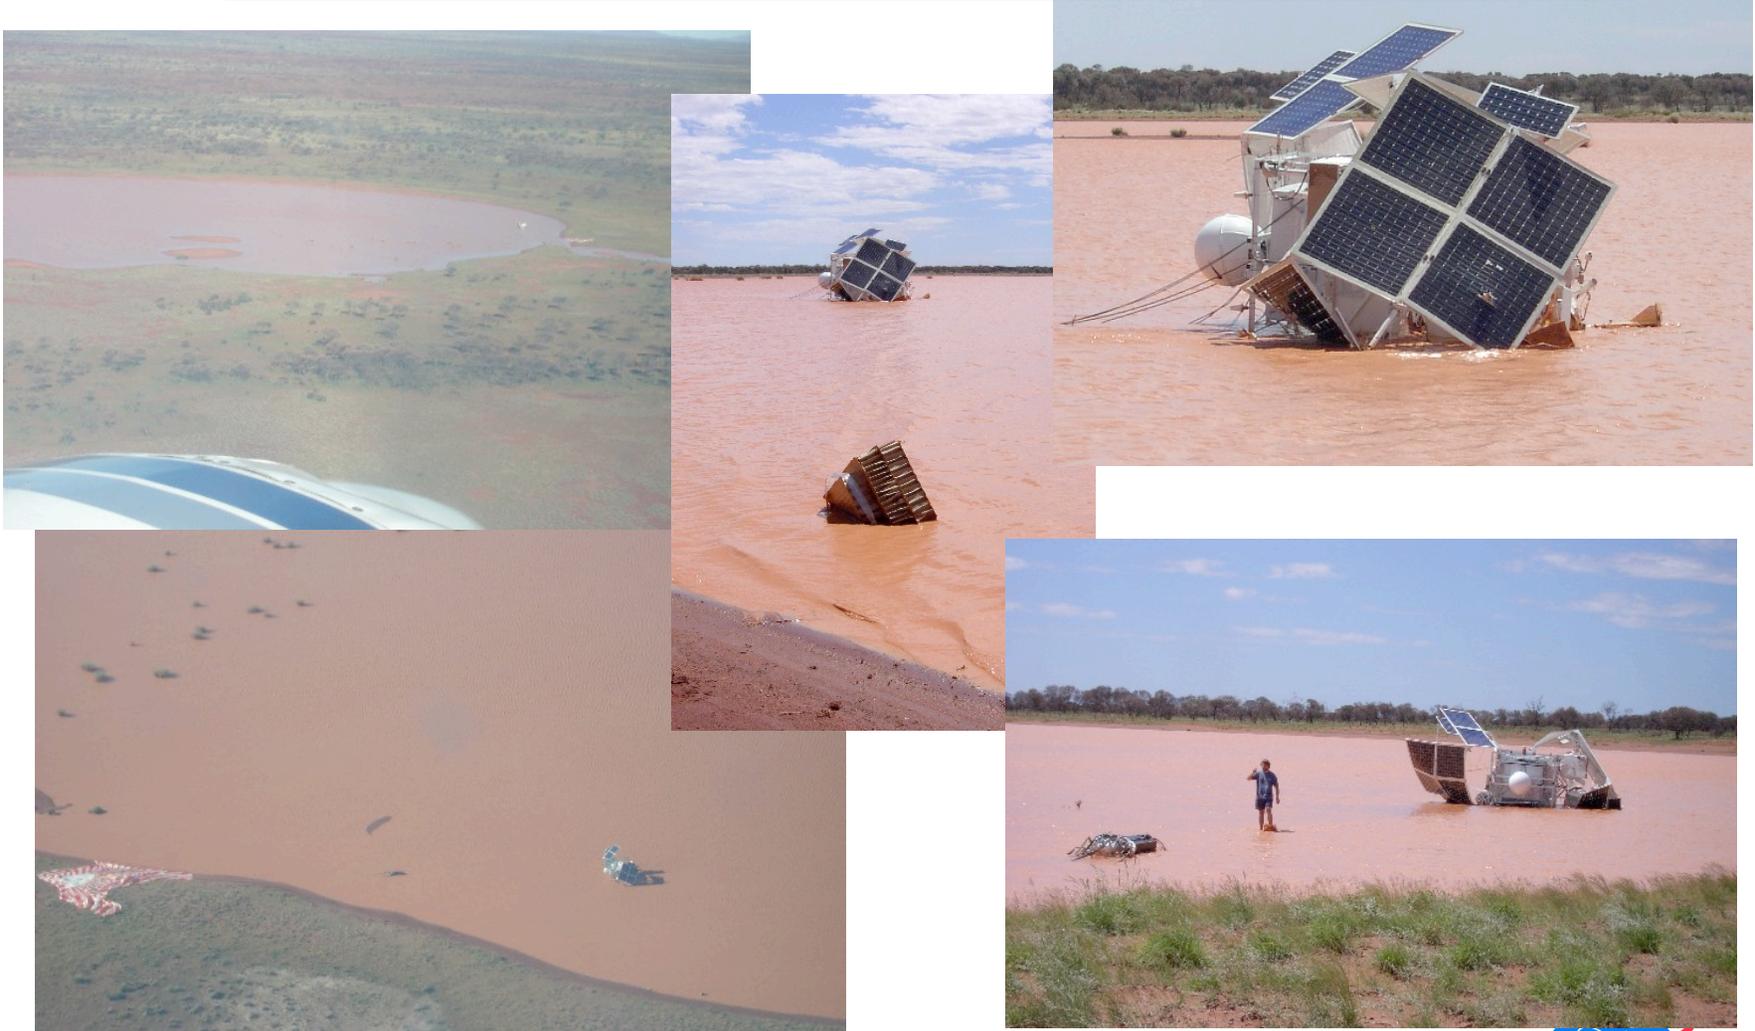
Recovery and Post Flight Photographs

- Payload found the only water for 100's of kilometers (“clay pan” Aboriginal Holiday spot)
- Balloon pile was a mess (like all balloons after flight) – damaged on descent
- Impact area measured (~33 ft by ~66 ft)
- Apex and base fittings looked as they did on launch
- All tendons were attached on apex and base
- Three small pieces of the balloon retrieved – final balloon recovery completed
- Balloon returned to the U.S. on June 20

- ARB - Investigating issues identified from “fishbone analysis”
- Balloon has just returned to the NSBF on June 20
- Inspection of balloon and accessories to be done July 7 to 11
- Design and modeling of potential fixes in process
 - Pattern design changes to ensure deployment
 - Approaches to “force” deployment being investigated
- Proposed verification plan to test “fixes” will be presented to BPO
 - All potential “fixes” will require fabrication and testing
 - Will include recommendations for each approach, test structures to be built, proposed test flights, schedule, and cost
